2. The history and importance of 5 Bolgam Street

5 Bolgam Street is included in the statutory list of buildings of special architectural or historic interest at Category B. This marks it as a being of regional significance. Its condition, ownership and lack of a viable use all mean however, that it is at considerable risk and this may be our last chance to save it. The local familiarity of this group of buildings has meant that it is not prized as an important part of Campbeltown's built heritage but taken for granted. Providing an accurate and objective assessment of the true significance of the complex is therefore considered a vital part of this Options Appraisal. For this reason, this section of this report is lengthy. If the building is to be saved, its standing needs a boost, people need to recognise how important it is. And if it is to be lost, then this may be the last opportunity to make a proper record of it and of its history.

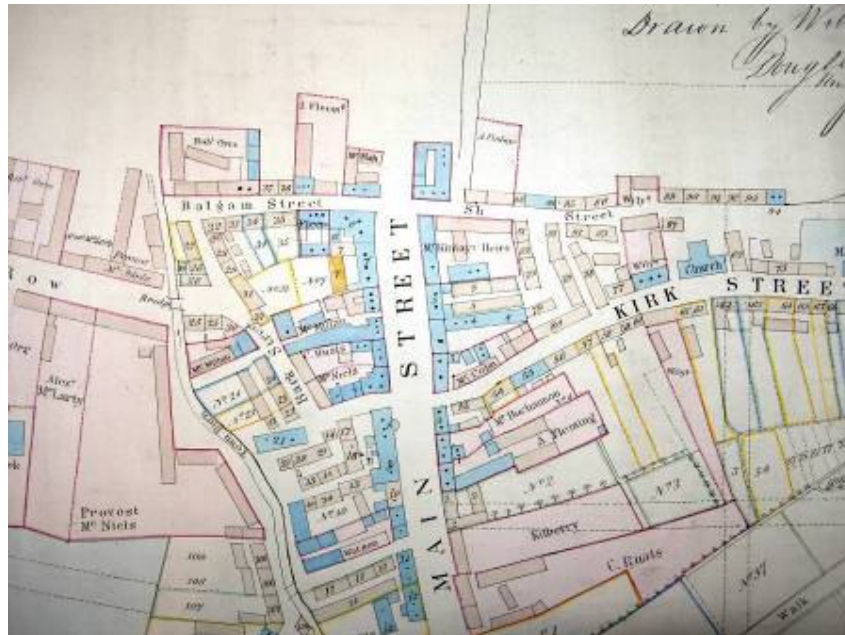
Figure 17: The central portion of the William Douglas map dated 1760 from the Argyll Archives. These maps are closely related but the increase in detail on this version is striking.

Here we see the form of the building similar to the RCAHMS version of the map but with its west side wing truncated. But the key allows us to understand more about the building.

The blue tint indicates a slate roof while the buff tint buildings are thatched. The dots on the buildings indicate the number of stories. So we can see that there was a three storey, slate roofed building onto Bolgam Street with a 2, storey slate roofed building to its south, linked by side ranges. These are neither tinted nor bear any dots which may indicate that they were of single storey and of simple construction. How the upper floors of the principle ranges were accessed is a mystery. It might be fair to assume an external stair but none is shown on the plan. It is worth noting however, that the plan shows no other external stairs so this may be a simple stylistic choice by William Douglas. Numbered properties are rented out directly by the Argyll Estate, while properties without numbers indicate that a feu has been let.

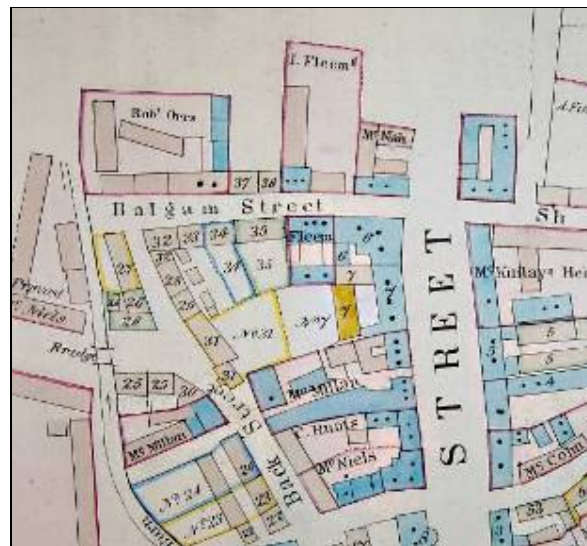
Figure 18: 5 Bolgam Street from the Argyll Archives map, annotated as belonging to I or J Fleeming.

It is interesting that the Bolgam Street building appears to have been of three storeys. Looking at the map, this was not entirely unusual and of course we don't know the form of the third storey but as Fenwick comments that in Pittenweem, merchants were often found sitting in the top storey of their houses, ranged around the harbour watching the loading and unloading of their ships⁶.

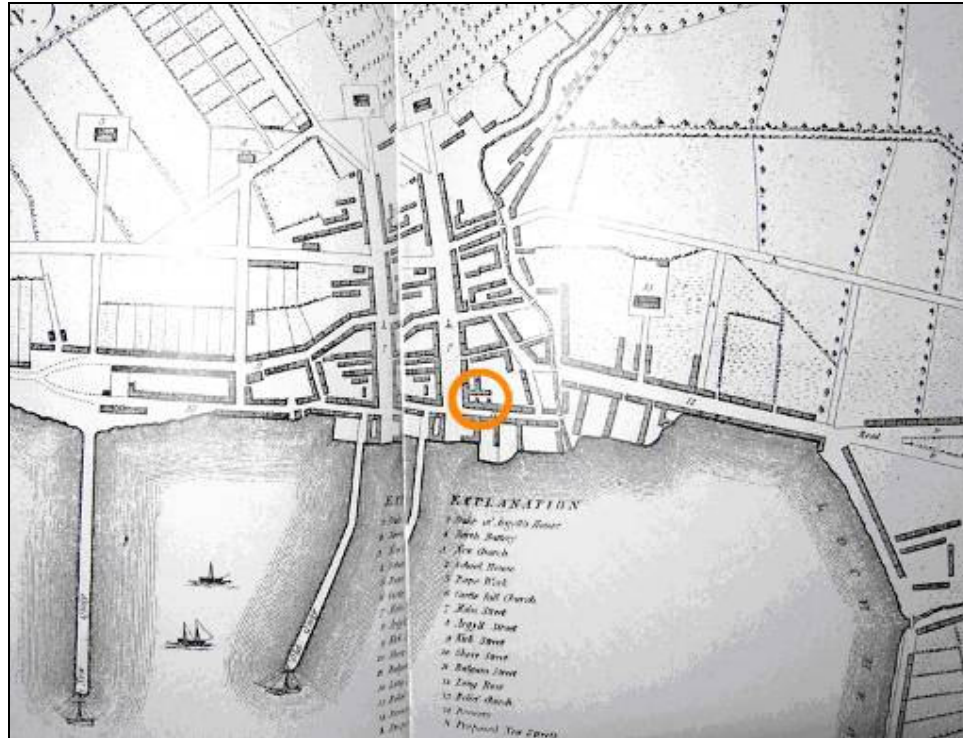
Figure 19: Excerpt from map by George Langlands and Son of 1801, this copied from the Campbeltown Book ⁷ which characterises this map as 'Stylized' The location of 5 Bolgam Street is ringed in orange.

Here both side wings by the courtyard are shown in a truncated form, perhaps a stair to the first floor of the Bolgam Street building was contained within one of these?

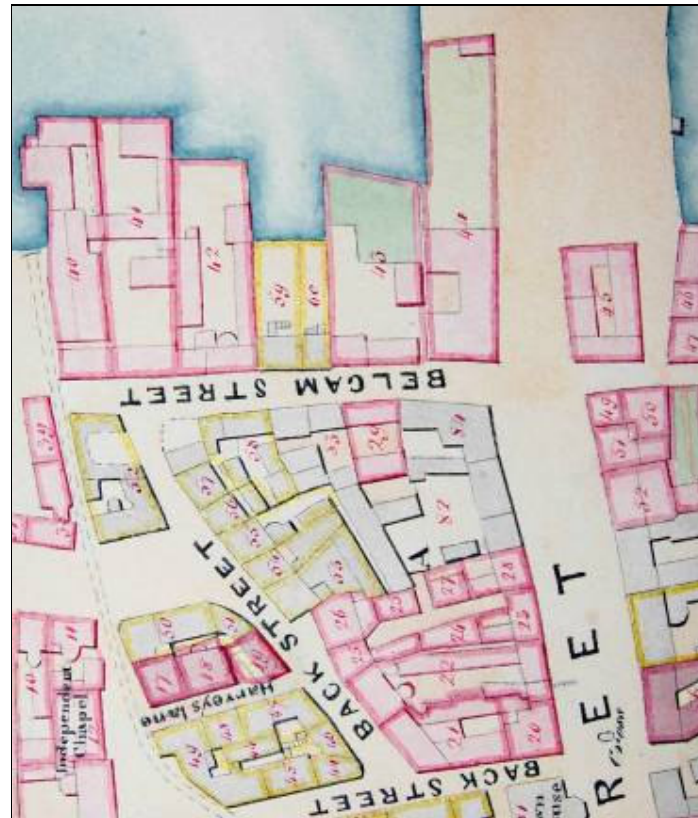
Figure 20: Excerpt from Waterston Town Map of 1841 contemporary with the purchase of 5 Bolgam Street by the Burgh of Campbeltown. 5 Bolgam Street is annotated 29. NB this section has been rotated to place north at the top of the map segment

The annotations 29 and 43 relates to the map schedule which indicates that these two parcels of land are owned by the Burgh of Campbeltown, confirming that this is the land they purchased from Archibald Fleming's estate. The form of 5 Bolgam Street seems to have remained more or less intact but no side wings are shown. Note also, the extent of building around the complex which is now more or less hemmed in on all sides.

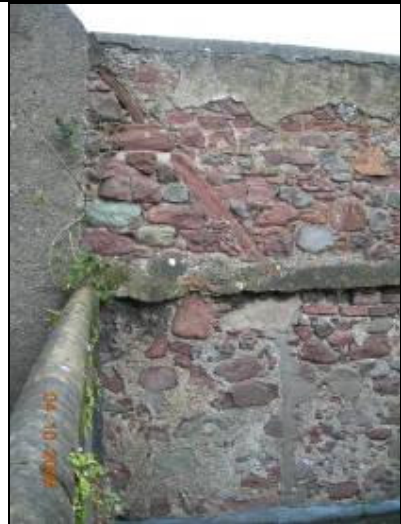
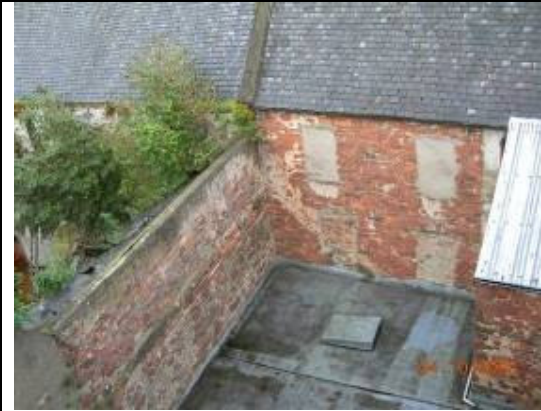
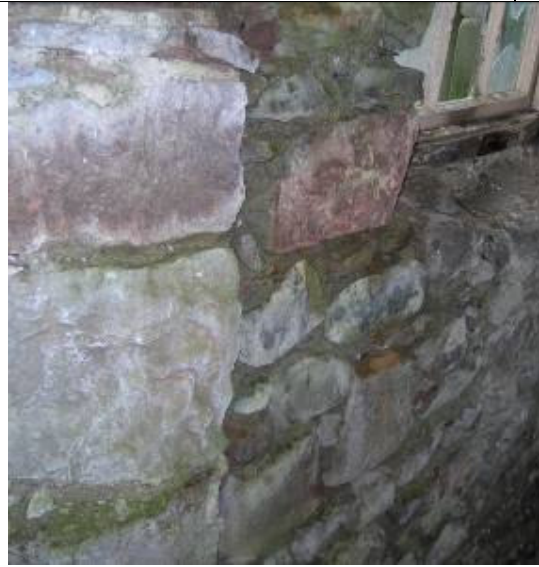
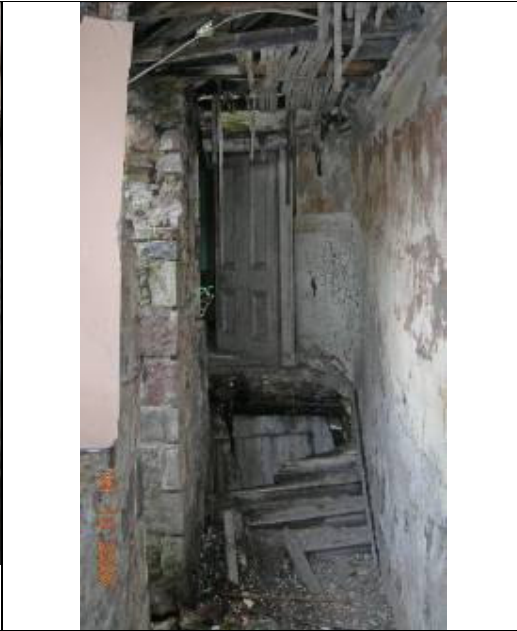
Figure 25: Illustrations of east wing

<p>a View of junction of east elevation, east wing and east gable south range, note the line of the cope stones extending below the current head of the wall</p>	<p>b View of the east gable east wing showing horizontal phases of development</p>

<p>c The junction of the east wing with the south range at first floor level illustrating the straight joint and lack of bonding of the stonework between the two</p>	<p>d View from south range looking north along the east range, first floor, note the taper to the end of the corridor.</p>

Looking at the rear (east) elevation of the east wing, there is evidence to suggest that this wall has been raised and internally the bonding of the east elevation with the Bolgam Street building and south range walls at first floor level is irregular. In addition, the first floor corridor tapers oddly at either end as it enters the north and south ranges, this taper only being expressed internally. The reason for this configuration is not clear.

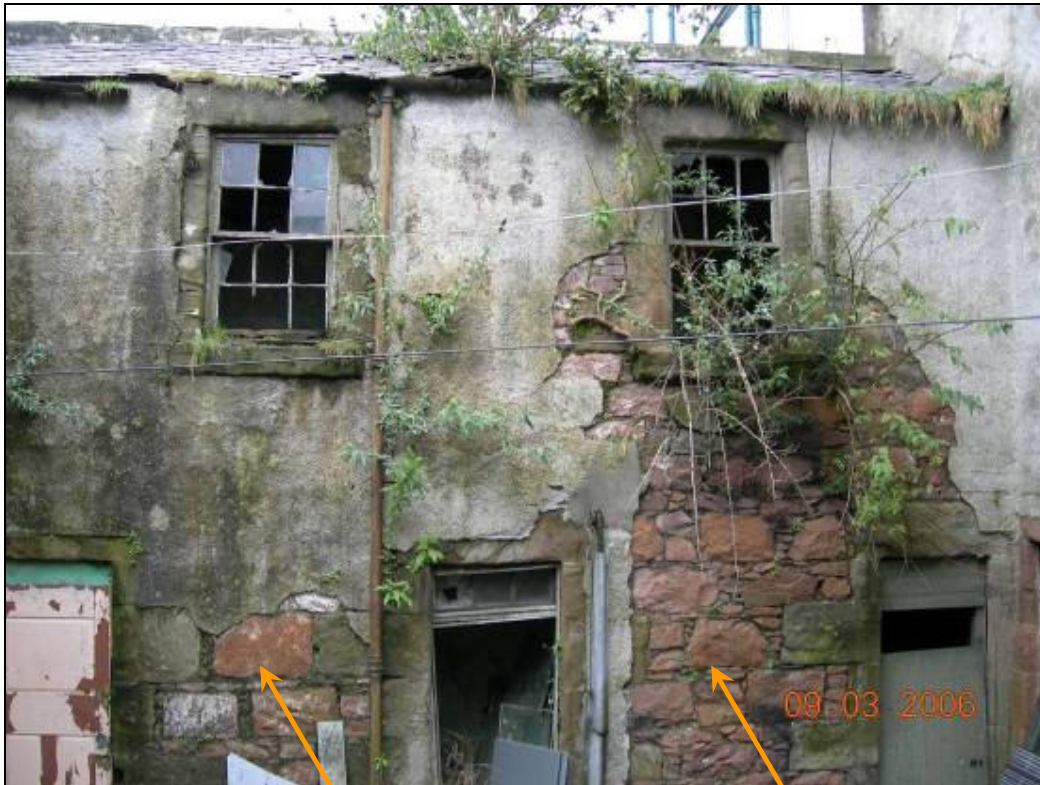
Area of squared
stone, possible
added later?

Area of coursed
rubble similar to
Bolgam Street
building

Figure 26: West wing, courtyard elevation illustrating differences in the pattern of stonework across the wall. *NB it is a mute point whether there is evidence of alterations to the stonework around the window and door to the north end of the wall. Perhaps therefore, alterations on the Bolgam Street building would not be visible.*

The photograph of the courtyard elevation shows to the left (south) squared and neatly coursed, but quite coarsely laid stonework with regular pinnings and wide joints. To the right (north) the stonework is far more random but more carefully laid, with narrow joints very similar to that in the Bolgam Street building and south range.

Stones are far more roughly coursed, with pinnings taking up more of the surface area.

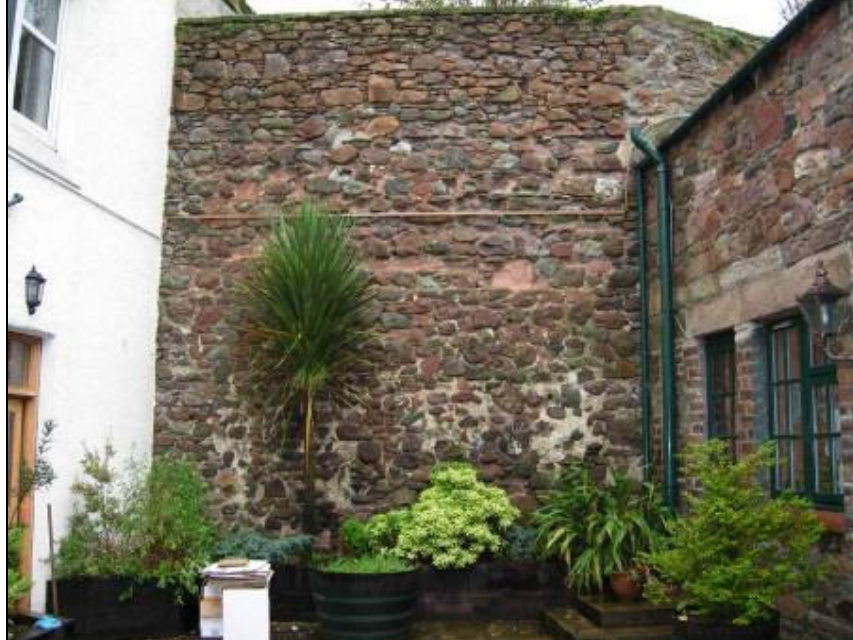
Figure 27: West elevation of west wing. There is evidence of horizontal layering of the stonework pattern extending up the wall face illustrating different phases of construction

The west elevation (forming the boundary with the courtyard to the rear of 7 Bolgam Street) is different again. Here the stones employed are much more like field stones, smaller in size and rounded. They are fairly randomly coursed to the lower section of the wall but more carefully placed higher up, more regularly coursed with rather more angular stones employed here. There are very few pinnings. The lower section of wall seems to have been harled at some time. In some areas, erosion has taken place, possibly indicating where roofs have *leaned to* in the past. The stonework at the south end of this elevation is heavily (harl) pointed with a cement mortar and its form is therefore unclear. Intriguingly, the pattern of the stonework at different levels is not that similar to that on the east elevation of the east wing and so no suggestion can be made as to whether these two walls and their alterations are contemporary.

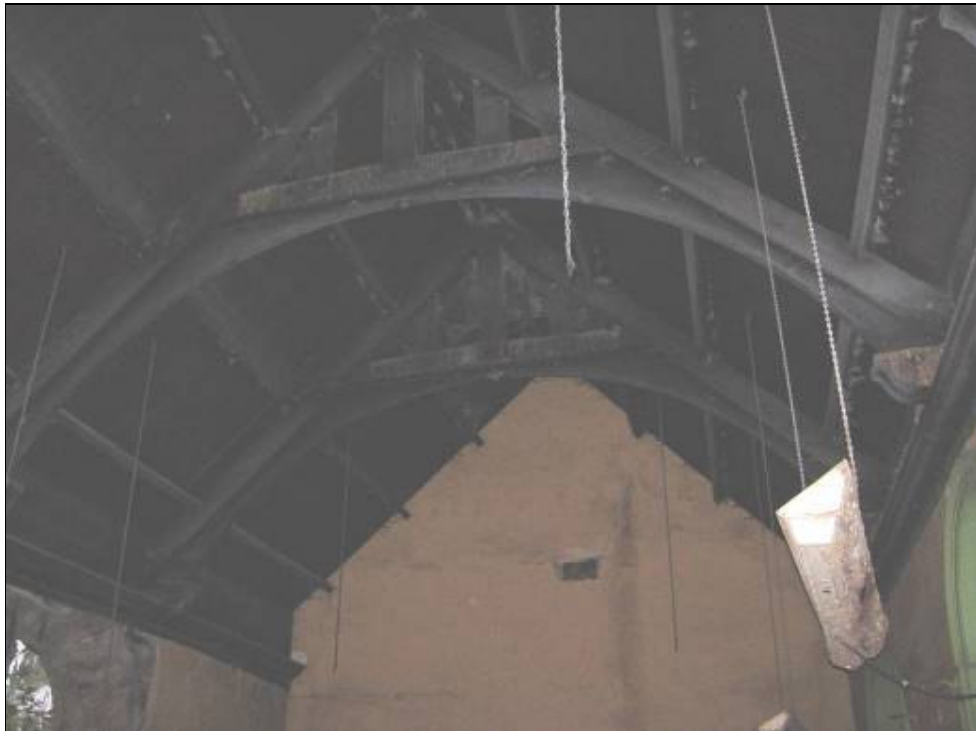
Figure 28: The roof structure over the main hall

The roof structure to the Bolgam Street building is expressed internally and is a thoroughly engineered rib and collar structure probably of pine of 4 bays, with three arch braced principle trusses. These comprise a pair of principle rafters made up of two parallel members bolted together (a flitch), trapping an arched brace. These are supported at the wall head by ovolo brackets, which presumably cantilever off the wall heads and are probably seated on a wall plate. A high collar ties the trusses, with three posts extending from its top up to the flitched rafters. The arched rib braces the whole truss, spanning the width of the room. The feet of the braces form the central section of brackets seated on the wall head. A ridge plate and three longitudinal purlins are visible spanning between the principle trusses. Vertical match boarding set on the plane of the wall, obscures the lower section of the roof pitch and junction of the trusses and the wall head. A moulded timber cornice runs through at wall head level forming the junction between the match boarding and lath and plaster wall linings.

This boarding extends across the soffit of the roof. Stylistically and structurally, this roof seems certain to date from the 1850's. Of course, we have seen from the map

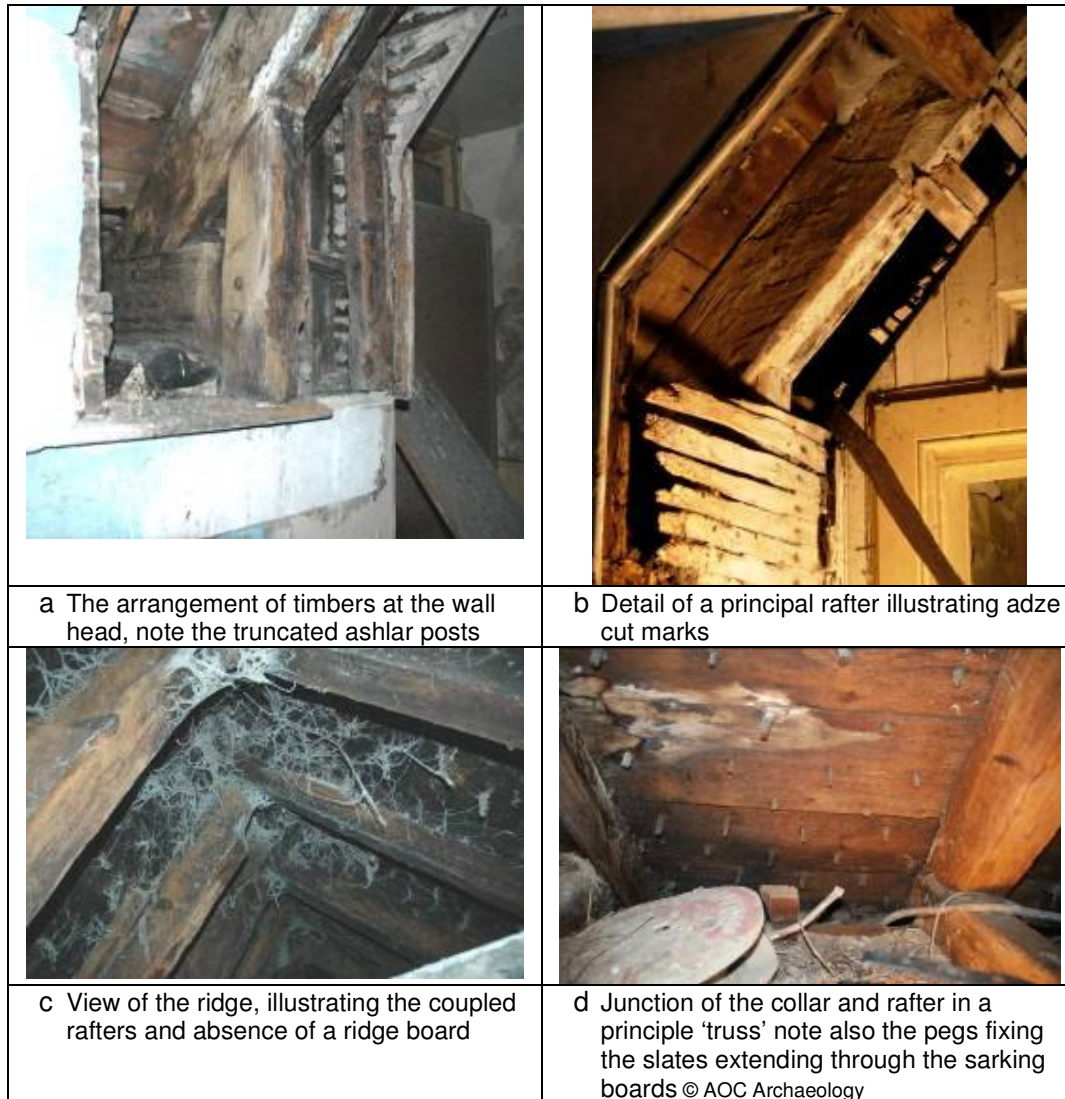
Figure 30: Details of the south range roof

5 Bolgam Street roof has no ridge board with each pair of rafters tied with a pegged half joint at the apex or ridge. This form of roof is known as a coupled roof and was common across England and at least the Lowlands of Scotland until the 19th century. Innocent ¹² comments that the close coupled roof may have originated in the Low Countries and have been imported to Wales by Flemish immigrants, perhaps it was in this way that the form came to Scotland also.
